"Can The Tower Be Retained"

Katalin Horváth

Abstract: This paper focuses on the analysis of two towers of an industrial plant exhibiting extreme deflection during service loads under heavy wind conditions. The towers are 90 m and 35 m in height, respectively and are interconnected with structural steel operating platforms.
The nuts have flown off at some bolted joints in the interconnecting steel structure due to high stress induced by deflections.
The deflections measured at the structural steel towers had nearly twice the value permitted by the respective standard in the case of the 90 m high tower and approached the value permitted by the standard in the case of the 35 m high tower.
The herein detailed complex study – covering the strength analysis of the towers, the analysis of wind effects, and the review of the foundations – has been elaborated in order to determine the causes and consequences of the experienced deflections at the plant as well as to conclude the eventual actions to be taken.

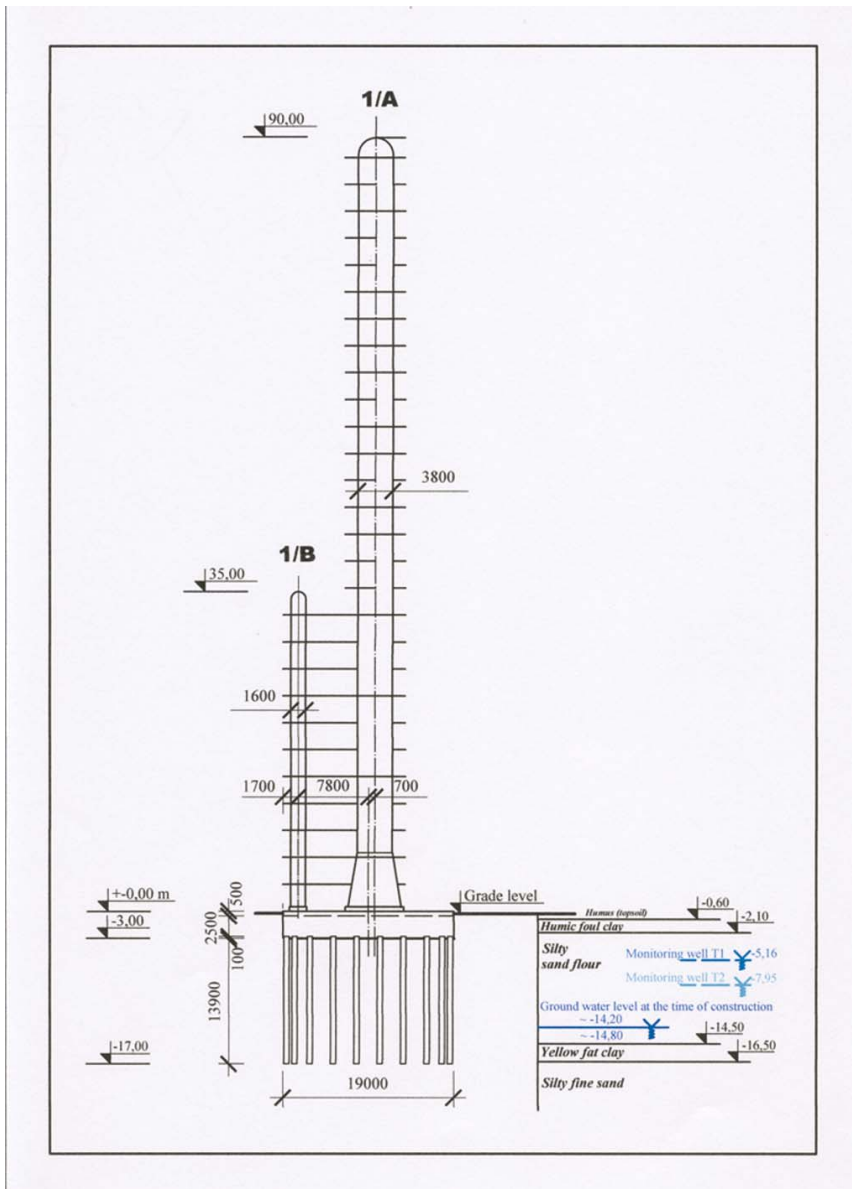
Figure 1. Side view of towers 1/A and 1/B, soil and ground water conditions

Significant deflections were observed in an industrial plant under the conditions of strong winds tower 1/A which measure 90 m in height and the tower 1/B of 35 m in height, which are connected to each other by structural steel walkways.
The deflection measured at tower 1/A was nearly twice the value permitted by the respective standard and on the other hand it approached the value permitted by the standard at tower 1/B.
Similar phenomena were observed already at the tower-like constructions in another unit of the same plant as well as at the tower-like constructions in another plant.
The structural steel towers 1/A and 1/B, mounted on a common foundation, were built more than 30 years ago, in the 1970s.
The common foundation of the towers is a reinforced concrete slab that is 2.50 m thick, with diameter of 19.00 m, supported by 52 reinforced concrete piles.
Tower 1/A is connected to the foundation by 48 ø75 mm anchor bolts and tower 1/B by 16 ø65 mm anchor bolts. The two towers are interconnected by structural steel operating platforms; the centre-to-centre distance between the towers is 8.50 m. The height of tower 1/A is 90.00 m and its inside diameter is 3.80 m while the height of tower 1/B is 35.00 m and its inside diameter is 1.60 m. The side view of the tower is shown in Figure 1.

The findings of the expert opinion on soil mechanics prepared on the basis of exploration drillings are as follows (Figure 1):
- The surface is covered by a 0.60 to 1.50 m thick layer of brown humic clay.

- Below this, down to ~ 13.80 m depth from grade level yellow silt mixed with floury sand and silty floury sand layers, respectively, of Aeolian origin, formed in the Pleistocene period – are located which change to foul clay at some places.
  These layers are in extremely dry condition and have a macro-porous structure according to the odometer tests with watering (i_m= 2.9% – 11.7%, i.e. susceptible to slumping)

- Ground water was detected only in deeper boreholes at ~14.50 to 15.00 m depth.
- The study recommended locally drilled Franki pile foundation as the foundation design for the towers and specified P_H= 95 Mp as the load-bearing capacity of the piles.

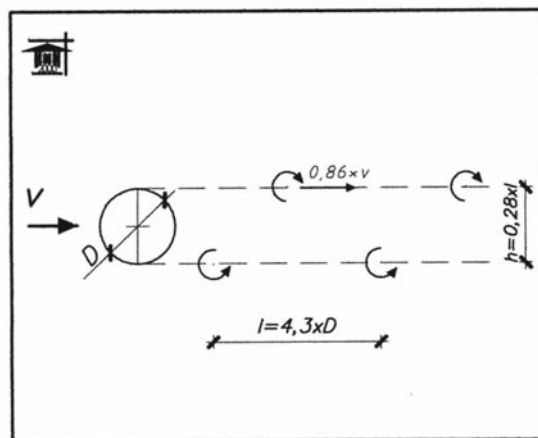
Figure 2. Karman type vortex path behind the circular cylinder

Based on the calculated and measured values it could be established that Karman effect occurred at the towers with lateral vibrations resulting from periodical vortex shedding (Karman turbulence) occurring at the towers at the critical wind velocity.

The Karman type vortex path developing around the circular cylinder is shown in Figure 2.

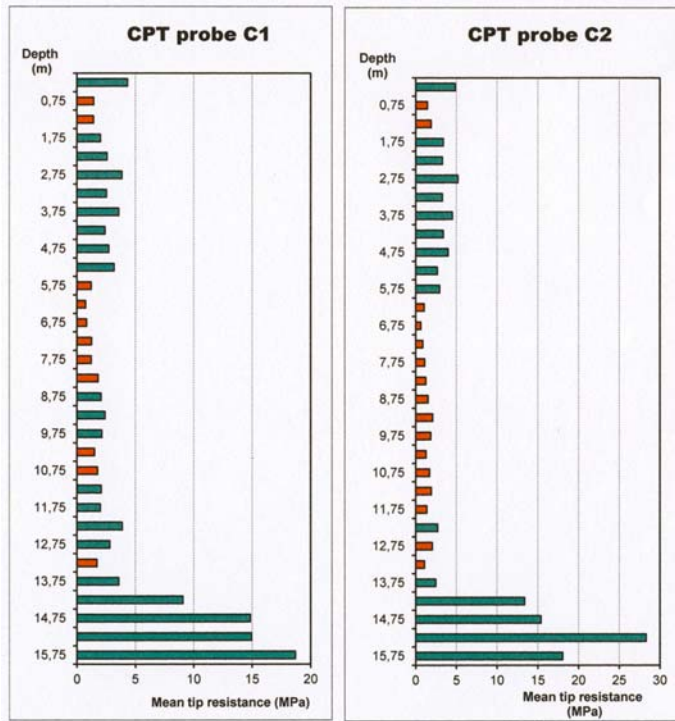
Figure 3. Typical mean tip resistance values of CPT probes

The following conclusions could be drawn from the results of the probe tests:
- The strata under 13.00 to 14.00 m, formed in the Pannonian epoch, have an unchanged good load-bearing capacity.
- The ~10.00 m thick layer of silt mixed with floury sand and silty-floury sand, respectively, above the strata formed in the Pannonian epoch is soil soaked by water – due to the rising and fluctuation, respectively, of the ground water level and its physical properties in respect of the load-bearing capacity have deteriorated.

Figure 3 shows the typical averaged tip resistance values of the CPT probes and Figure 4 shows the typical averaged values of impact counts for dynamic probes.
In the case of the CPT probes the values indicated in red colour are below 5 MPa and the value of the tip resistance dropped even below 1 MPa at some places.
In the case of the dynamic probes the values indicated in red colour represent impact counts less than 5 and even 0 and 1 values were recorded at some places.

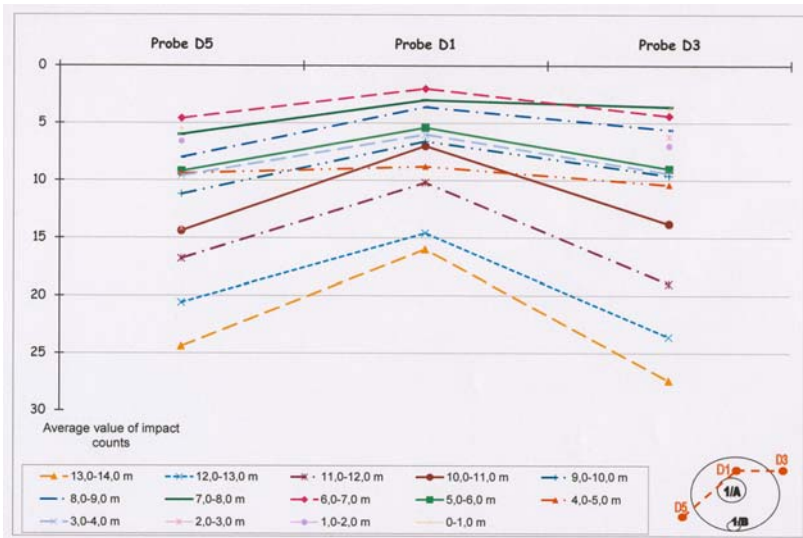
Figure 5. Section taken by dynamic probes D5-D1-D3 (mean impact counts)

Figure 5 shows the averaged values of the dynamic probes in the section taken by the dynamic probes under the tower foundation proving that the soil properties have deteriorated significantly under the foundation.

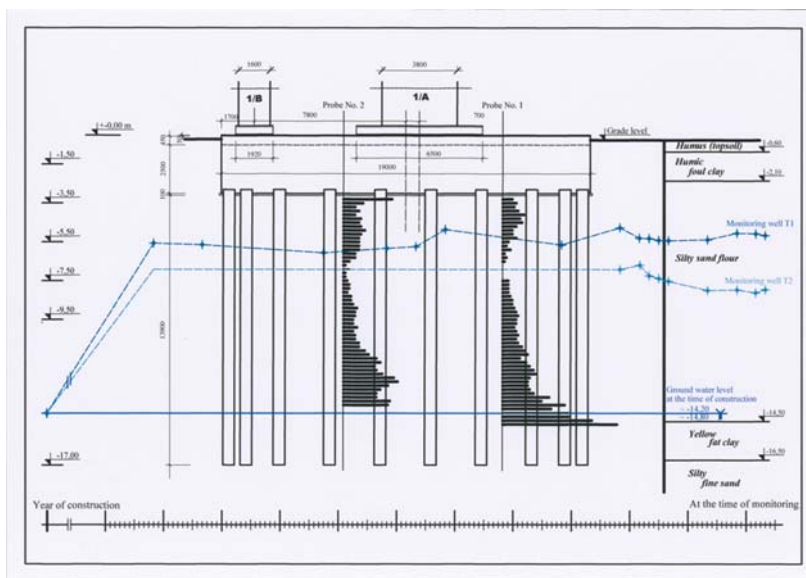
Figure 6. Rise in ground water level as determined by dynamic probes under the tower foundation

The results of both the CPT and dynamic probe tests indicated that the ground water level varied between ~6.00 m and ~8.00 m below grade level.

The ground water approached to ~1.80 m the bottom plane of the foundation slab.
Figure 6 shows the rise in ground water during the past nearly thirty years and the readings of the dynamic probe tests under the tower foundation.

The variation in load-carrying by shell friction due to the rise and fluctuation of ground water level means ~20% reduction in the total load-bearing capacity which is still within acceptable limits.

The rise in ground water level entails ~1–2 cm post-subsidence withdrawn over a long period of time.

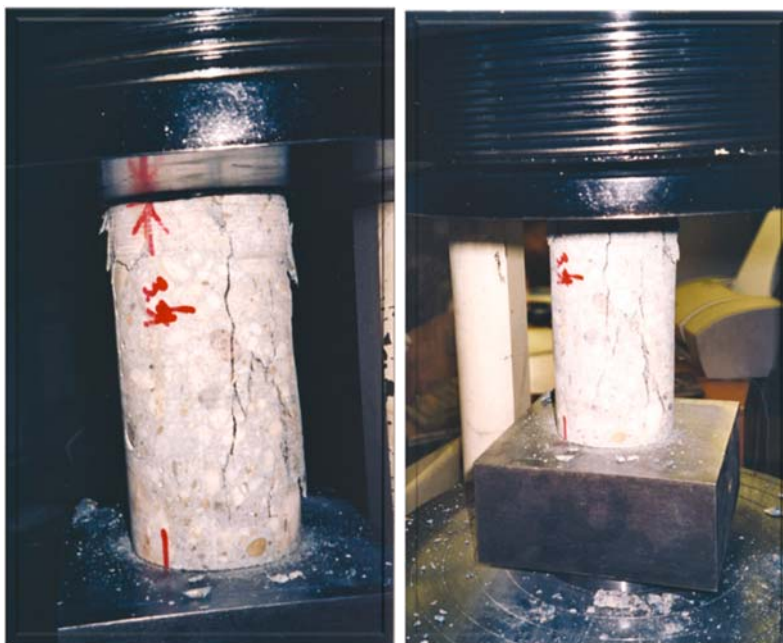
Photos No. 1 and 2: Concrete tests

Concrete core samples were taken by drilling through bores at two locations in the foundation and cutting out along 70 cm length at one place for determining the quality of the reinforced concrete foundation.

Based on the compression and tensile strength tests of the concrete specimens the strength class of the concrete is C40 while B200 (~C16) was the designed class.

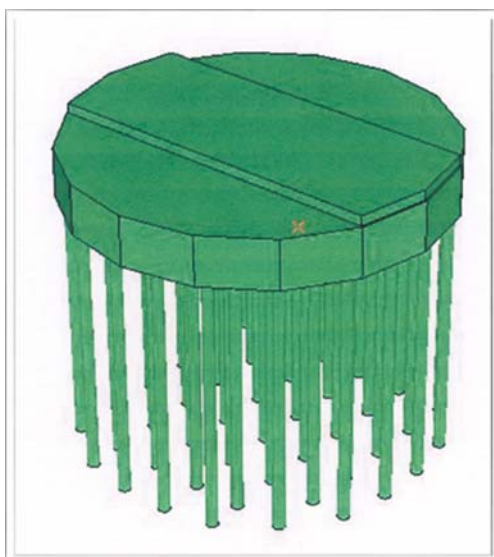
Figure 7. The finite element model built for checking the foundation

The calculations were performed by the Axis VM7 finite element computer program and computed manually. The finite element model built for checking the foundation comprises 2133 nodes and 4058 surface elements (see Figure 7).

Based on the results of calculation the load-bearing capacity of the piles and the foundation slab was evaluated and the anchor bolts and deflections were investigated severally.

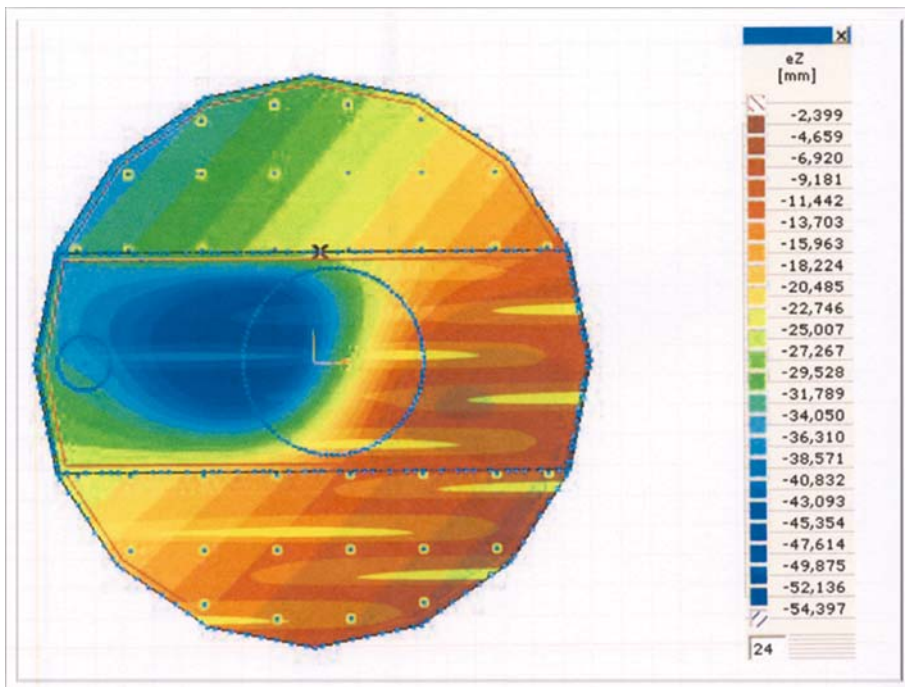
Figure 8. Subsidence

The constant obliquity of the towers was measured: the maximum resultant skewness is ~285 mm. The obliquity results in a constantly acting eccentric load.

The maximum value of the subsidence calculated for various load combinations is ~60 mm (see Figure 8) and the maximum difference between the subsidences calculated for various points is 54 mm which may cause 300 mm tipping but was acceptable according to the standard specification effective at the time of design.

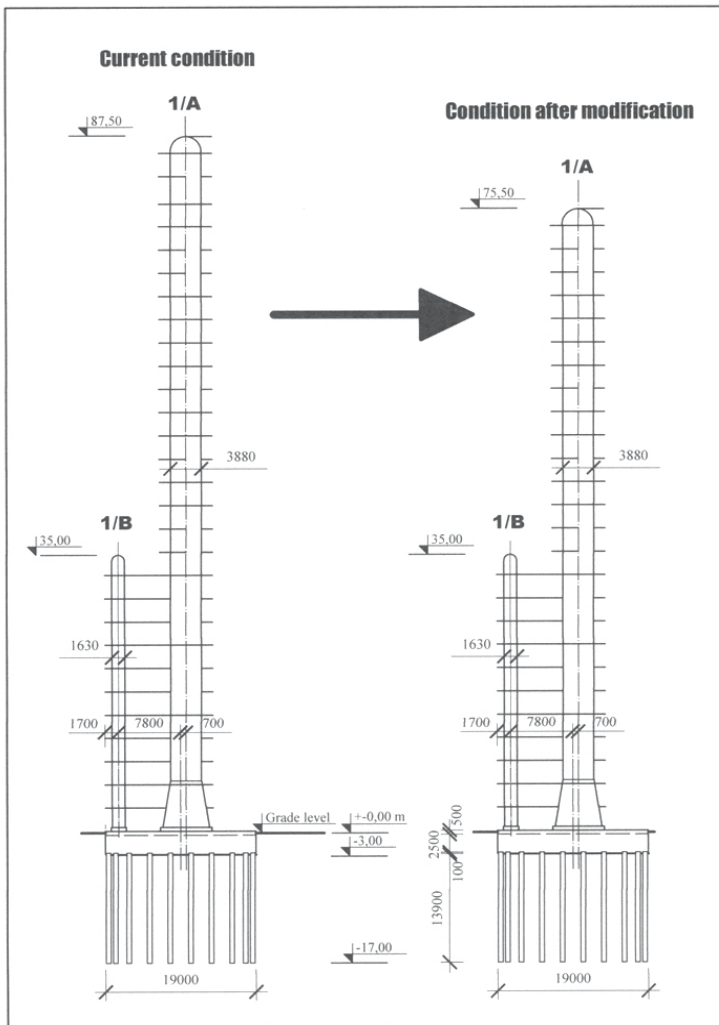
Figure 11. Reduction of the height of tower 1/A

The load-bearing capacity of the piles, the foundation and the anchor bolts were found acceptable. The reduction of the height of tower 1/A by 12.00 m resulted in the reduction of the dynamic problems but additional vibration dampening and foundation strengthening may become necessary.

In order to reduce the dynamic effects the top 24 trays are removed from tower 1/A and its height is reduced by 12.00 m to 75.50 m (see Figure 11).
Tower 1/B remains on the existing foundation in unchanged condition and tower 1/A with its height reduced to 75.50 m.
